New York State Department of Transportation

Yellow Flag NB2222W006

BIN: 1065318
Feature Carried: 278I278IX2M23027
Feature Crossed: 6TH AVENUE
Orientation: 8 - NORTHWEST
Region: 11 - NEW YORK CITY
County: KINGS
Political Unit: City of NEW YORK
Approximate Year Built: 1962
Posted Load Matches Inventory : Yes
Bridge Load Posting (Tons) : Not Posted for Load
Primary Owner: New York State Department of Transportation
Primary Maintenance Responsibility: 12 - State - Subcontracted to another Party
Typical or Main Span Type: 3 - Steel, 02 - Stringer/Multi-Beam or Girder
This Bridge is not a Ramp
Number of Spans: 322

Location: Span 251, Girder G19 at Pier 251

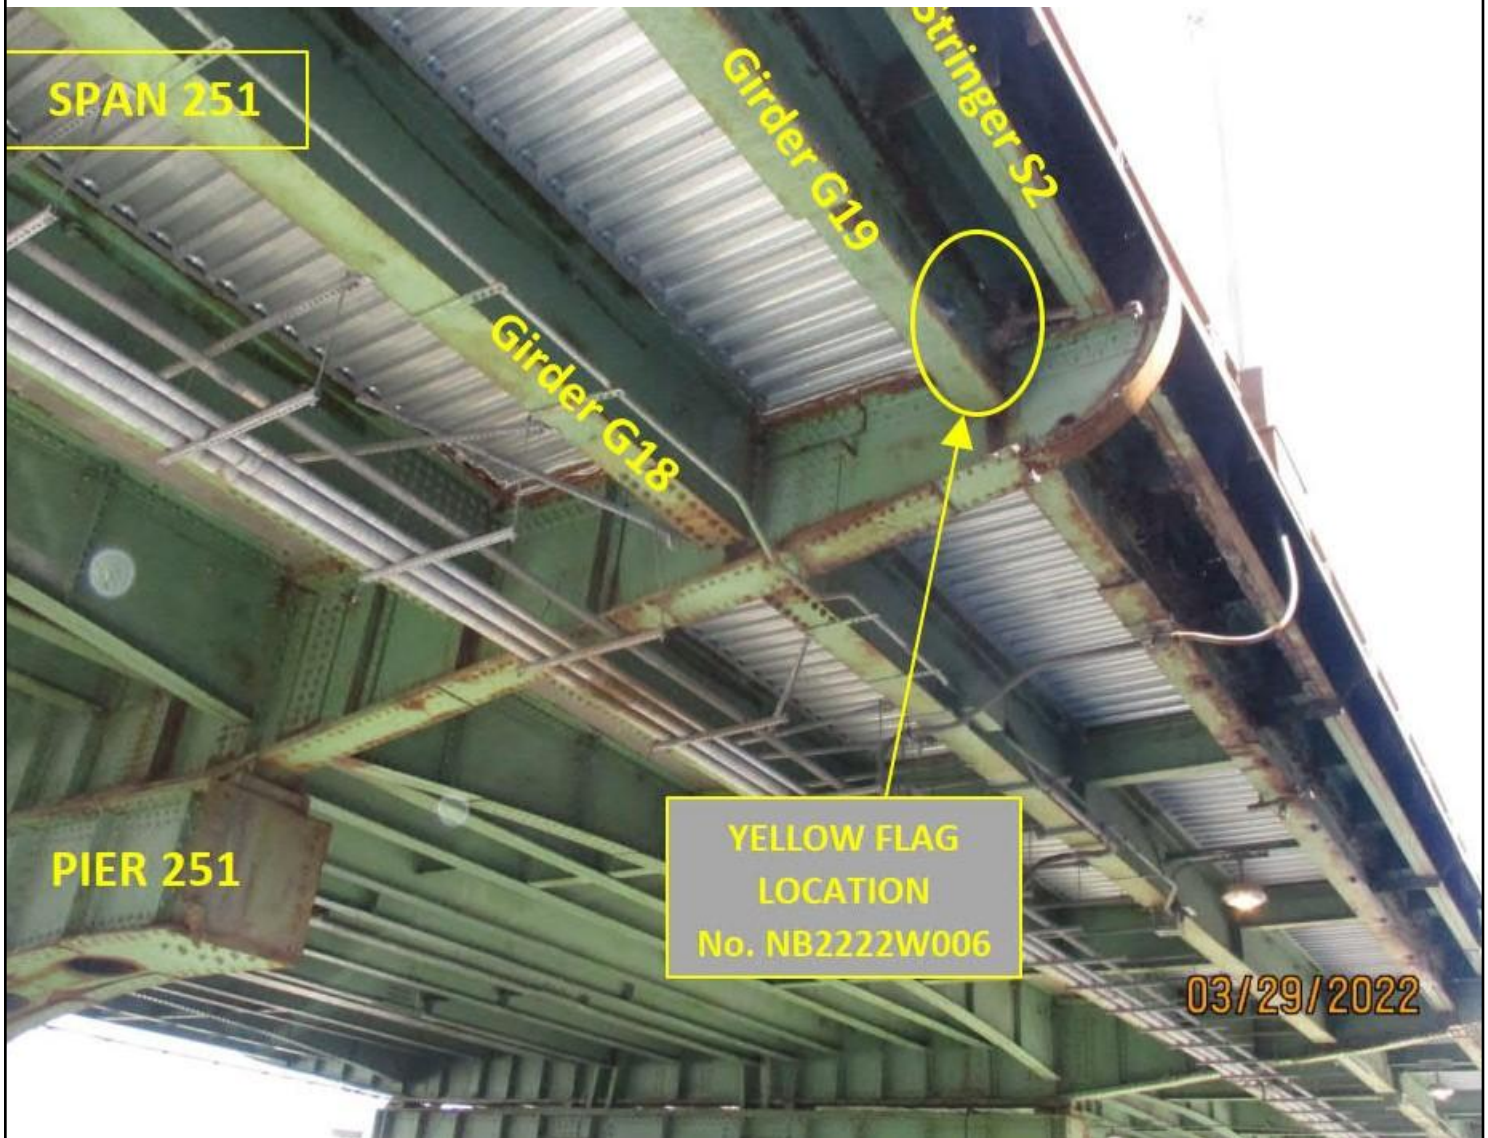
Photo Number: 1

Attachment Description: Span 251, Girder G19 at Pier 251. General view of the flagged location at pier cap connection. Looking end left.

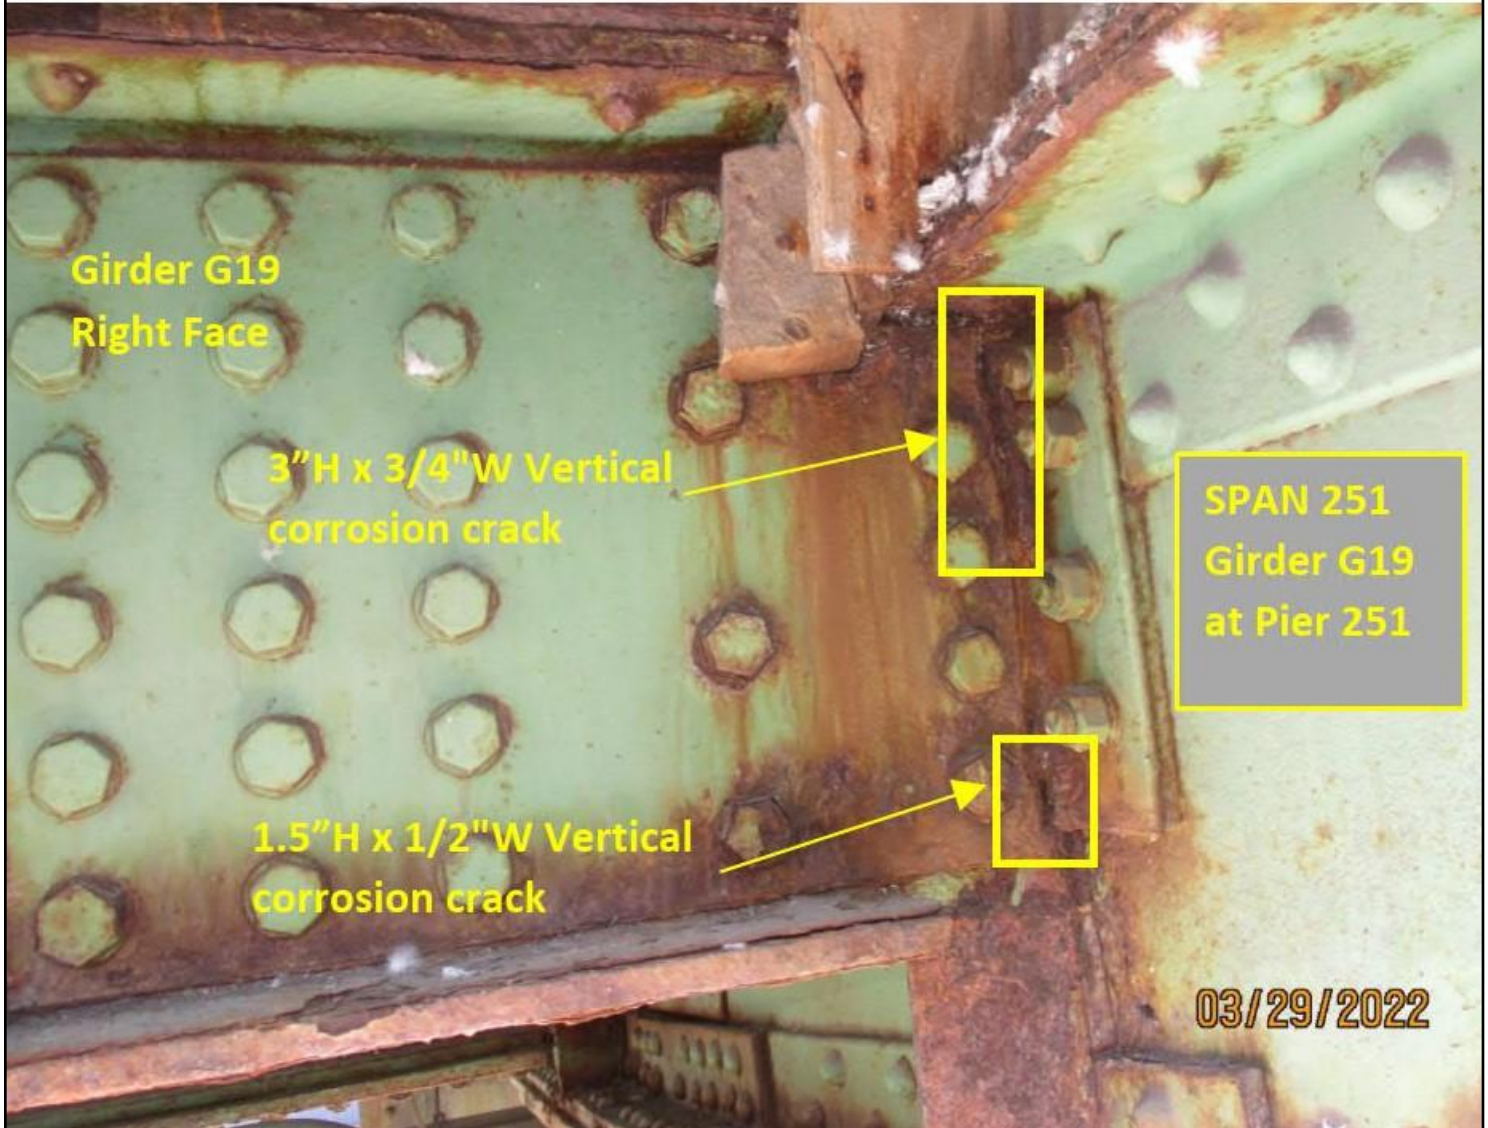
Photo Number: 2

Attachment Description: Span 251, Girder G19 at Pier 251. Close-up view of flagged location. Looking left.

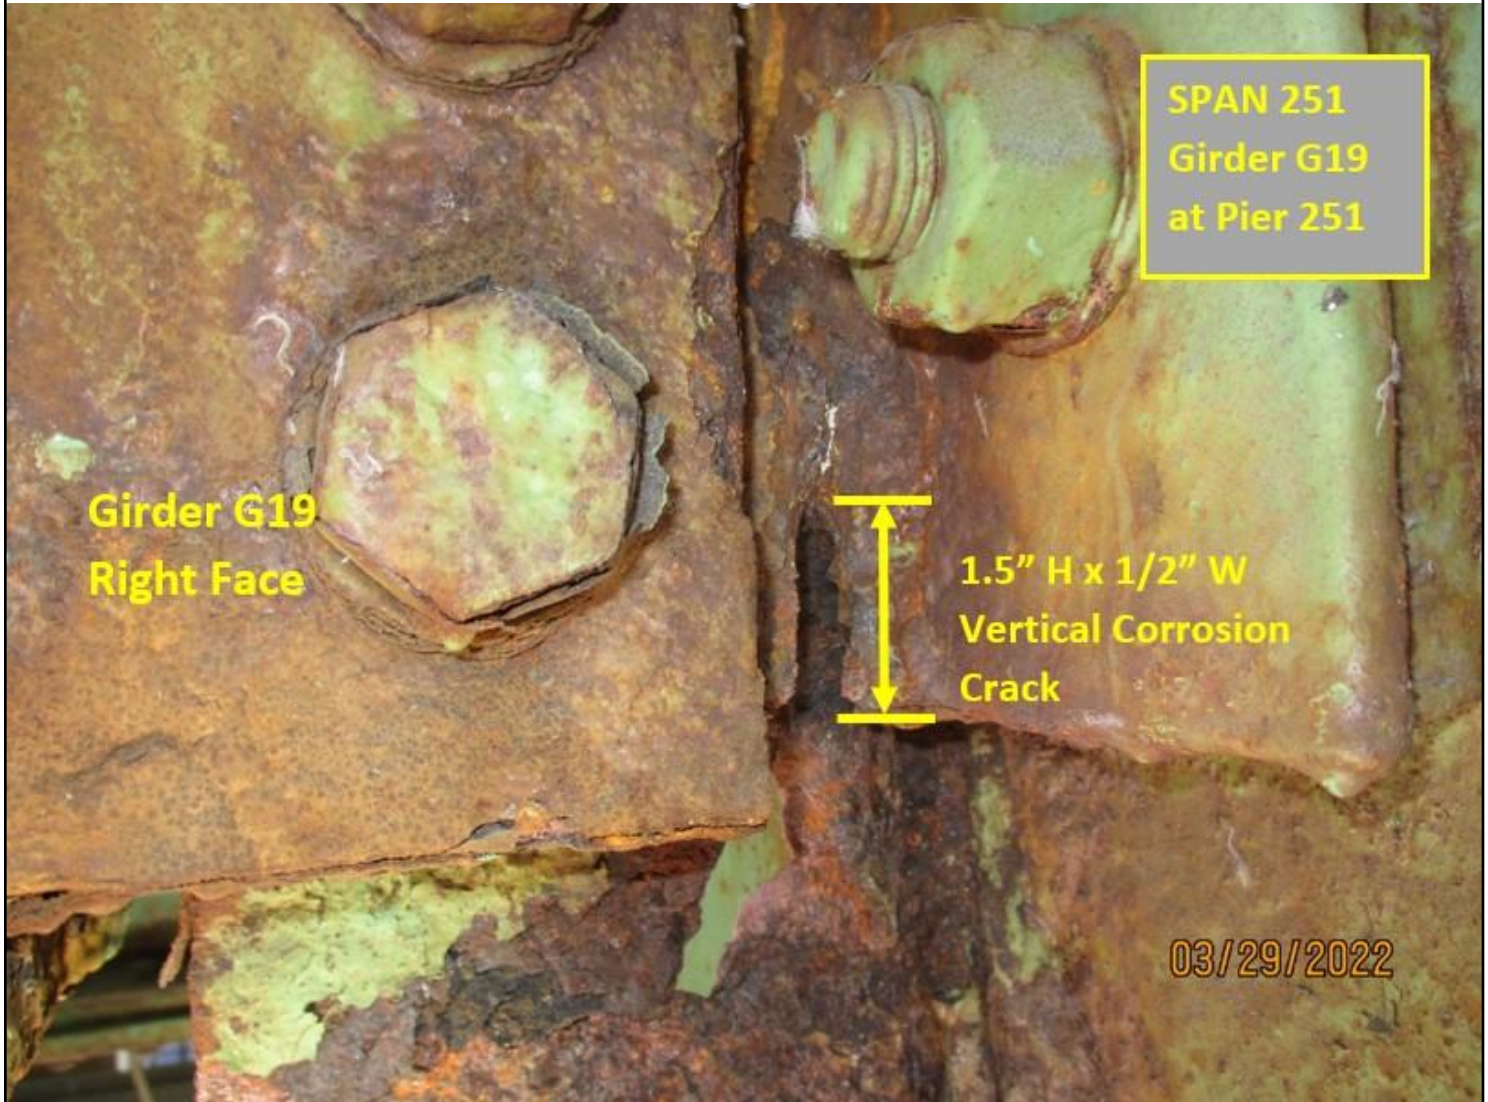
Photo Number: 3

Description: The right connection angle at Girder G19 connection to the pier cap at Pier 251 exhibits a 1.5" H x 1/2" W vertical corrosion crack at the lower fillet section (previously noted to be 1.5" H x 1" W) and a 3" H x 3/4" W vertical corrosion crack at the upper fillet section (no change). The remaining height of the connection angle exhibits up to 30% section loss for 6" H at lower portion (no change) and up to 50% section loss for 3" H at the upper portion (no change).

Attachment Description: Span 251, Girder G19 at Pier 251. Close-up view of a 1.5"H x 1/2"W vertical corrosion crack at the lower fillet section of the right connection angle. Looking end left.

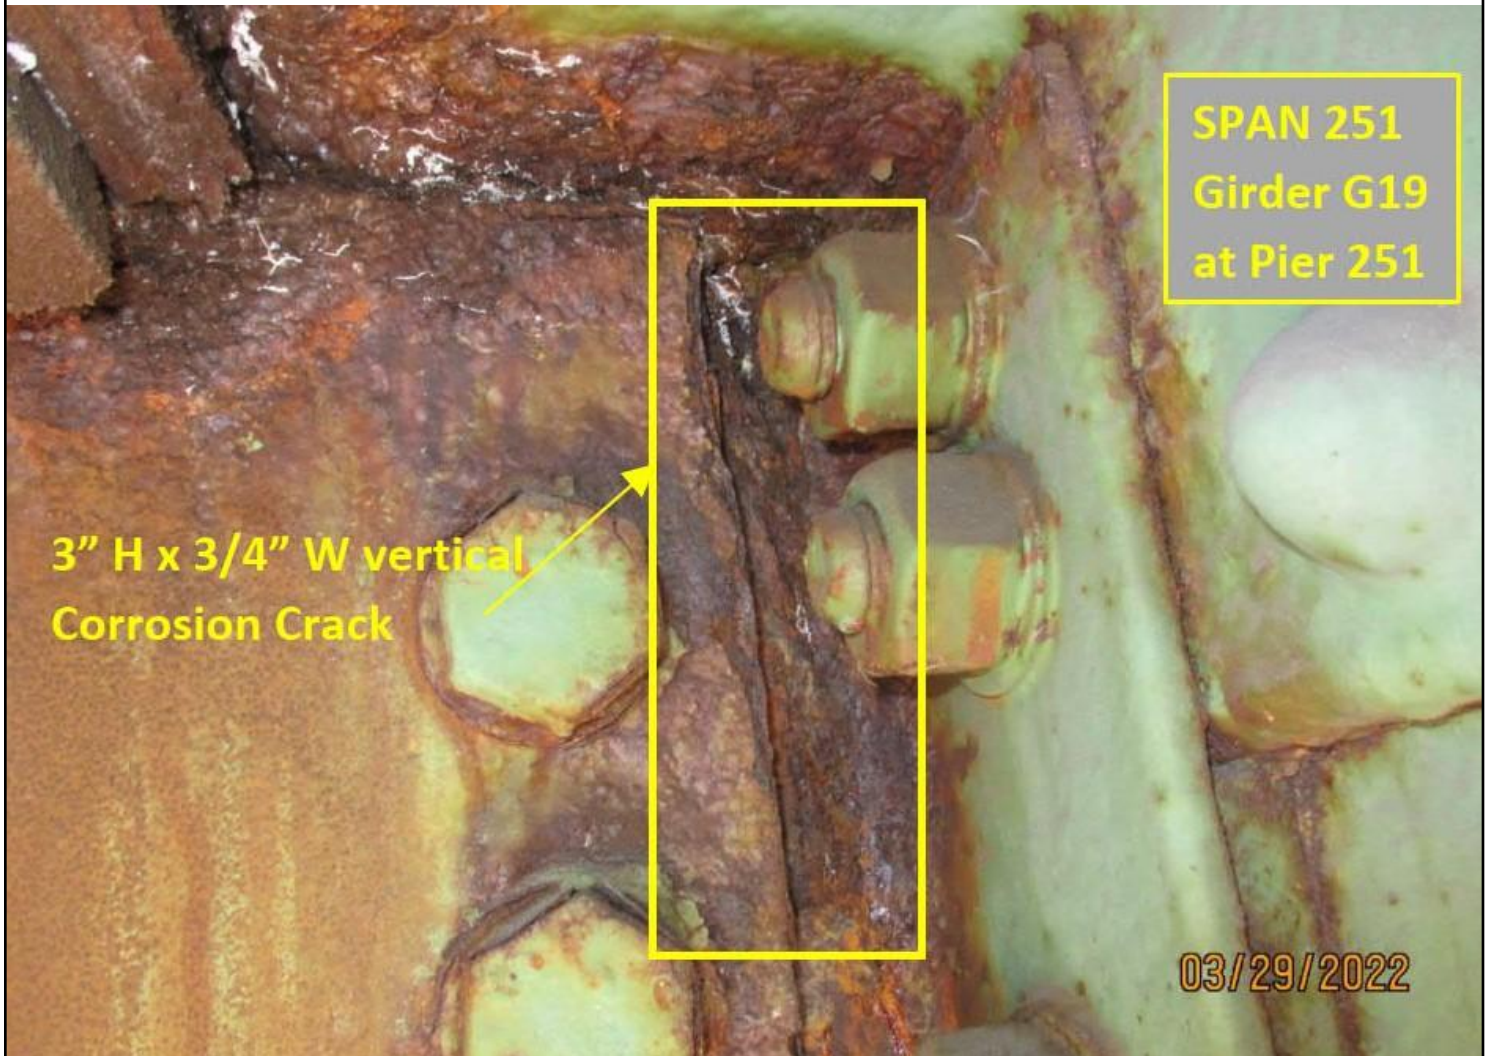
Photo Number: 4

Attachment Description: Span 251, Girder G19 at Pier 251. Close-up view of a 3" H x 3/4" W vertical corrosion crack at the upper fillet section of the right connection angle. Looking left.

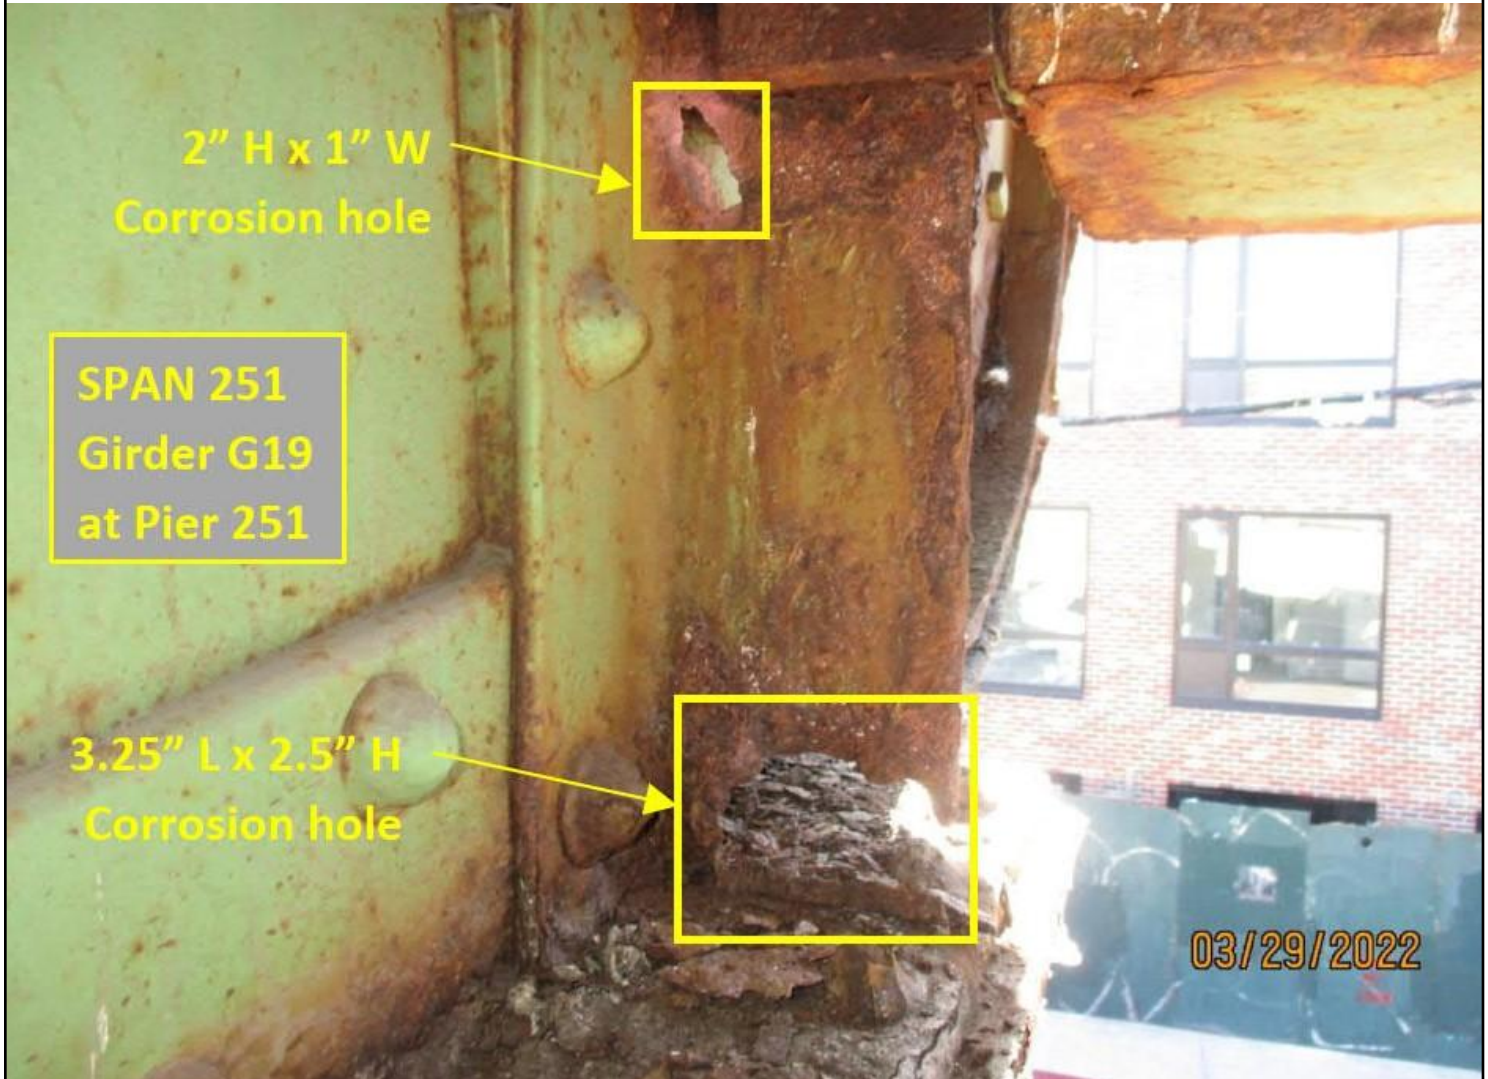
Photo Number: 5

The left connection angle exhibits a 3.25" L x 2.5" H corrosion hole at the bottom (no change) and a 2" H x 1" W hole at the Girder G19 bottom flange level (previously noted to be 7/8" L x 1.25" H). Additionally, there is 1.5" H area of up to 90% section loss at the top of the connection angle. Remaining height of the connection angle exhibits up to 20% section loss.

Attachment Description: Span 251, Girder G19 at Pier 251. Close-up view of a 3.25" L x 2.5" H corrosion hole and a 2" H x 1" W corrosion hole at the left side connection angle stiffener. Looking end right.

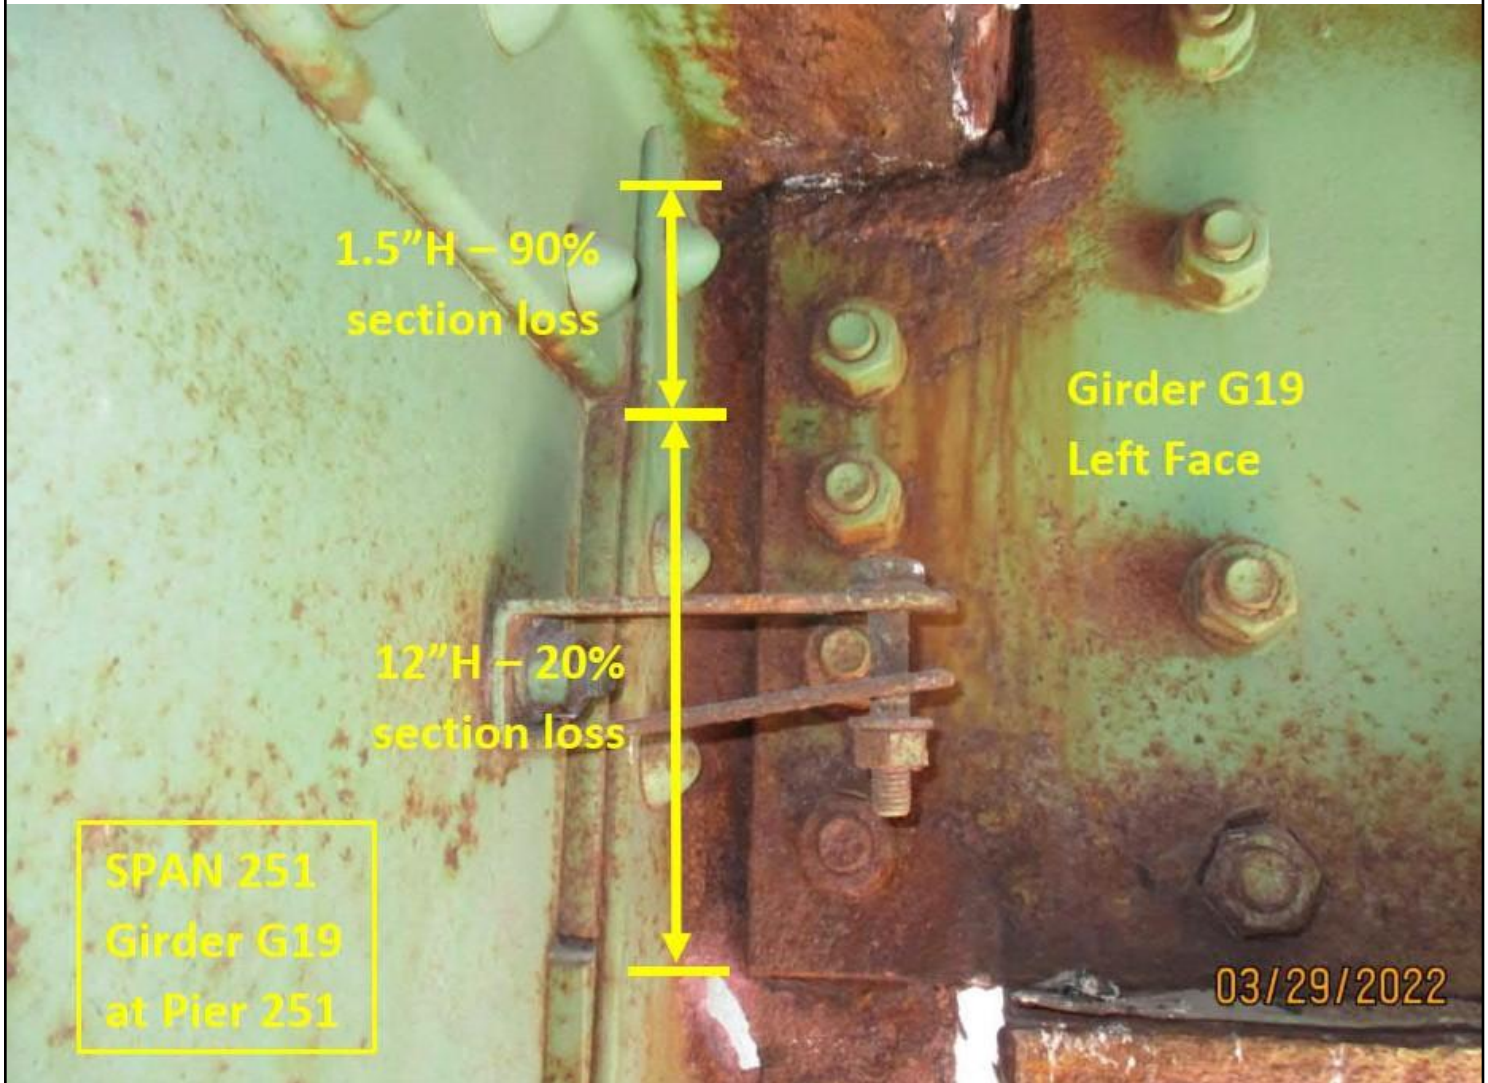
Photo Number: 6

Attachment Description: Span 251, Girder G19 at Pier 251. Close-up view of section loss area at left side connection angle. Looking right.

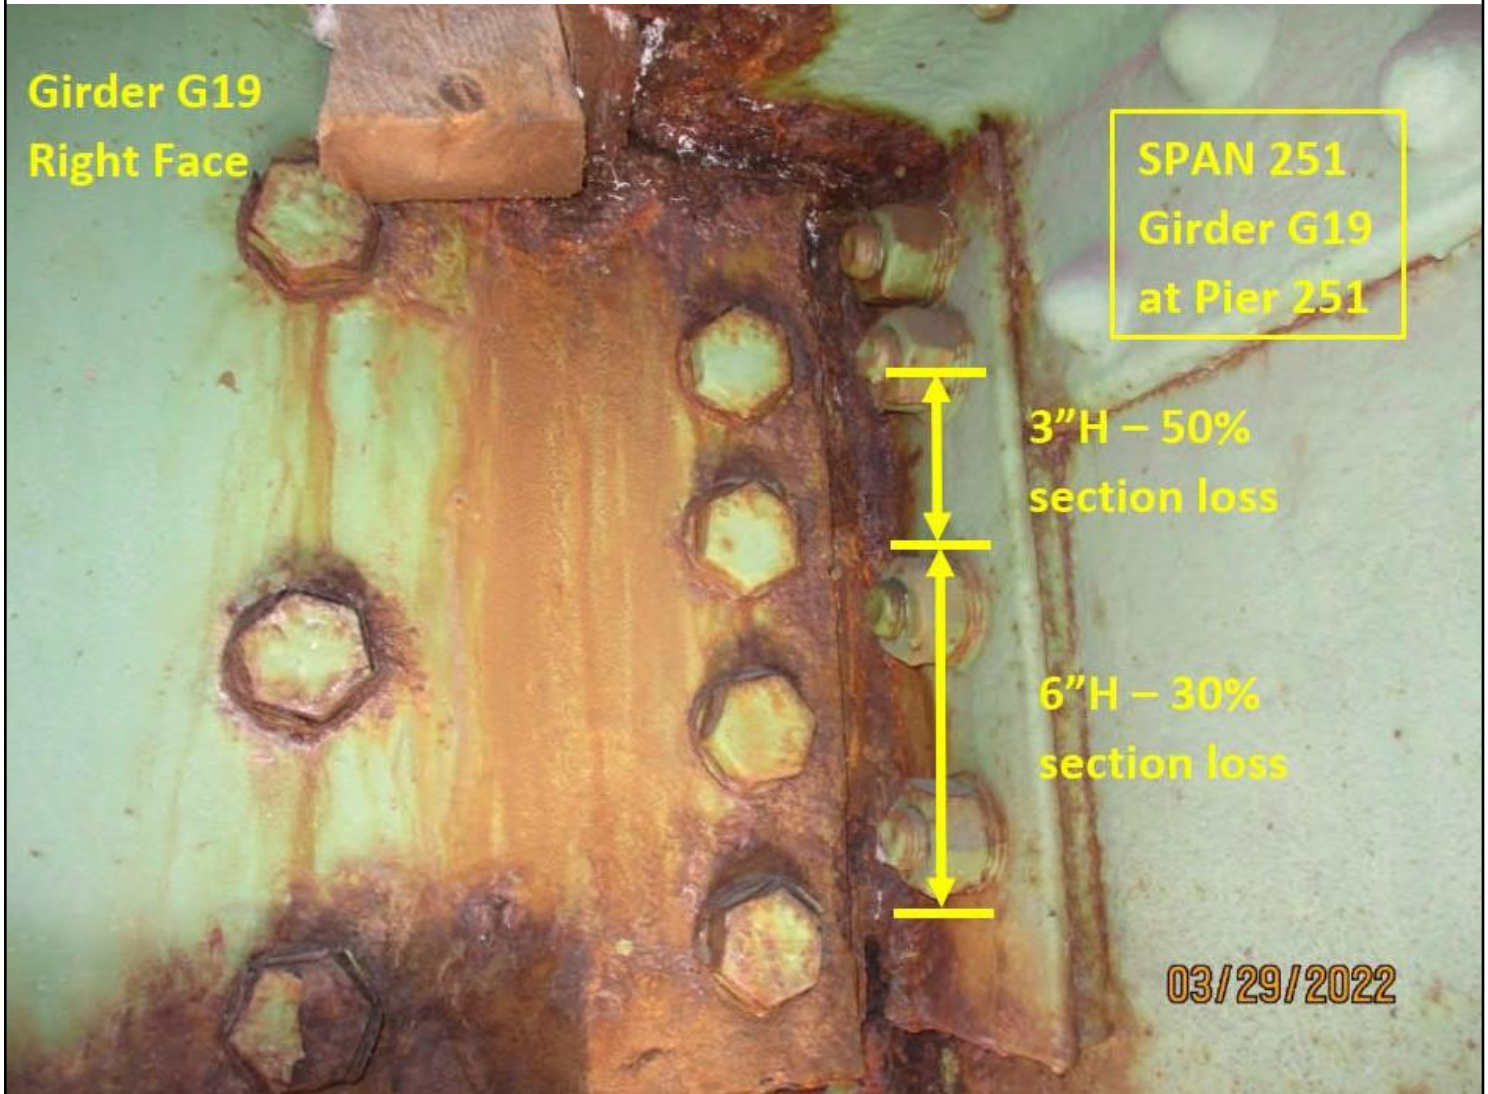
Photo Number: 7

Attachment Description: Span 251, Girder G19 at Pier 251. Close-up view of section loss area at mid-section of the right connection angle. Looking end left.

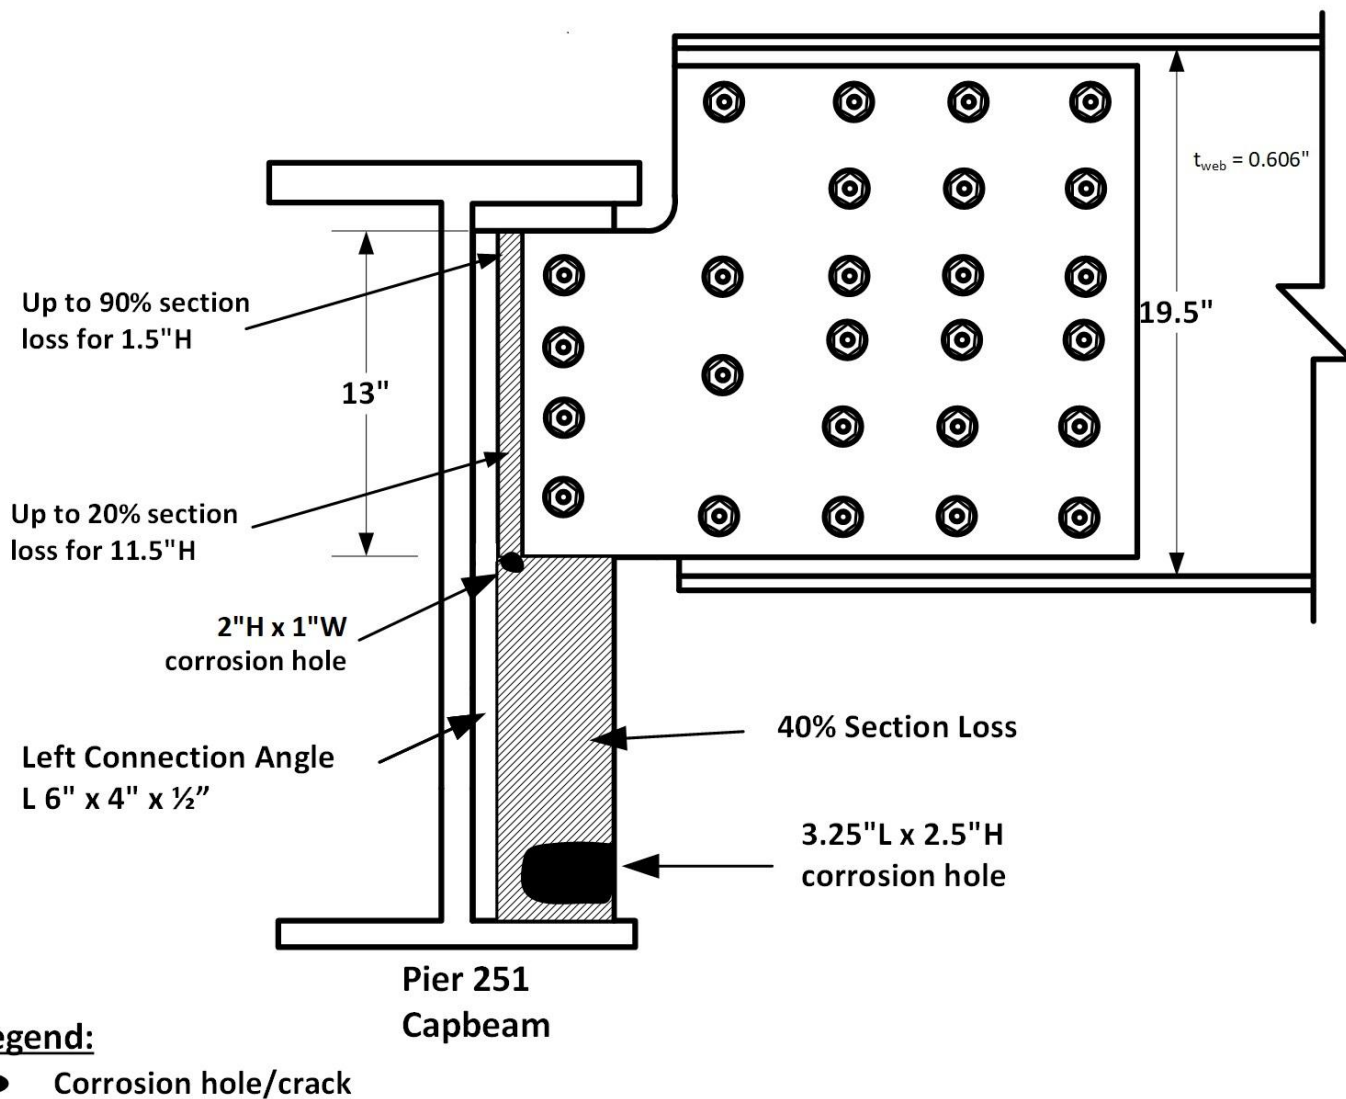
Photo Number: 8

Attachment Description: SN 251 G19 at Pier 251 Sketch Looking Right

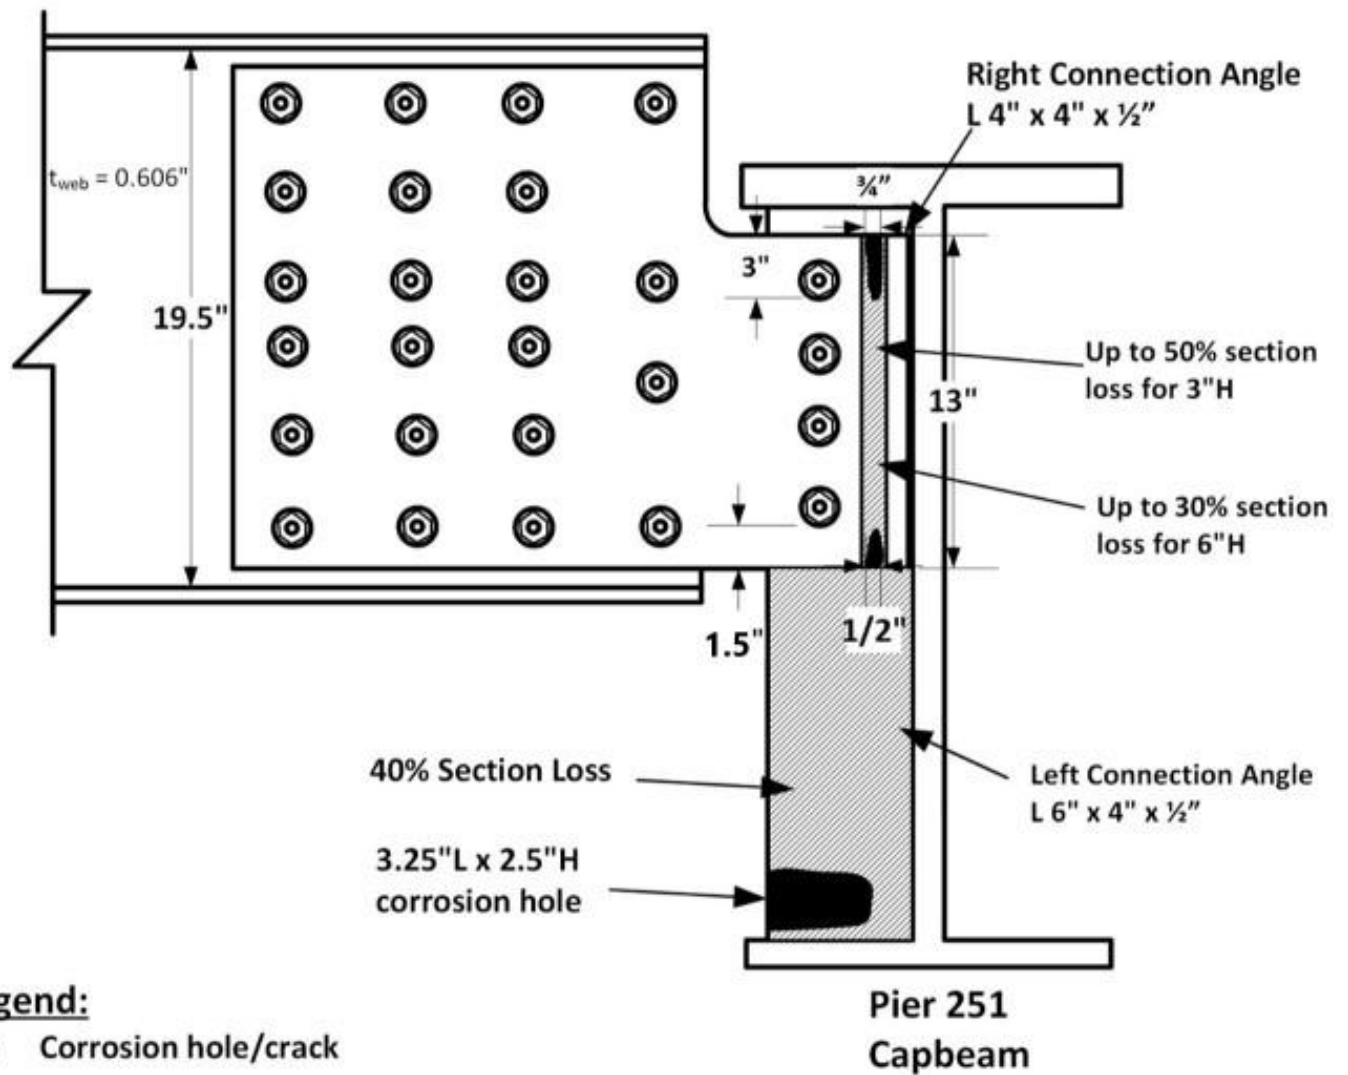
Photo Number: 9

Attachment Description: SN 251 G19 at Pier 251 Sketch Looking Left

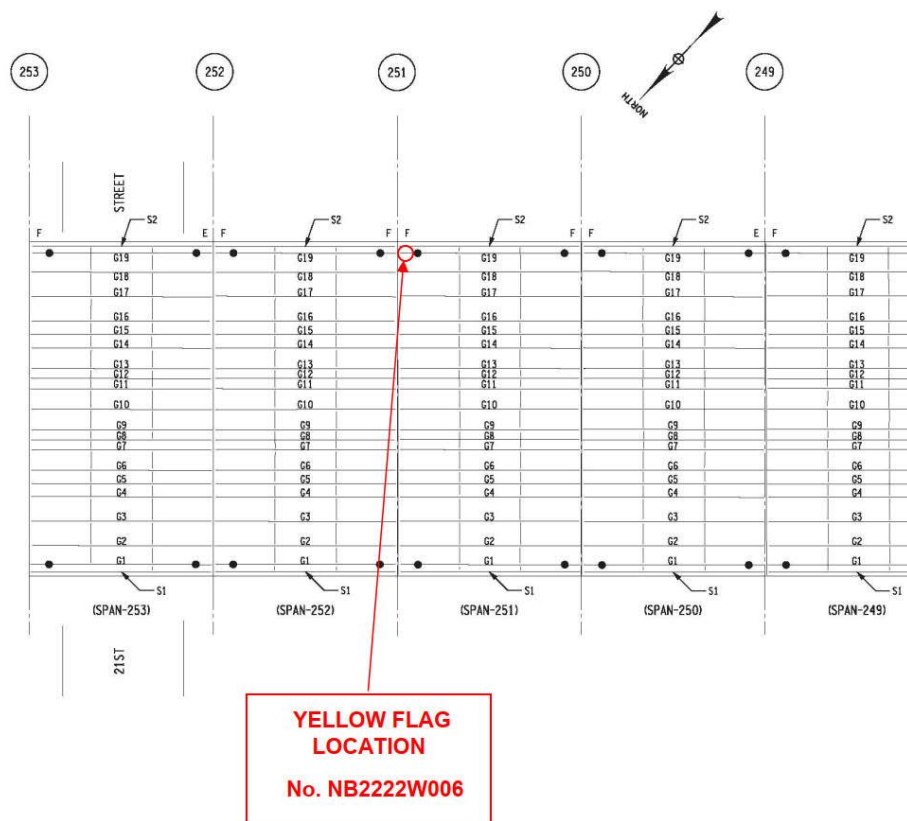
Photo Number: 10

Attachment Description: SN 251 G19 at Pier 251 Framing Plan
